**FIELD SURVEY
OF
CACTUS CRATER STORAGE FACILITY
(RUNIT DOME)**

REPORT A08

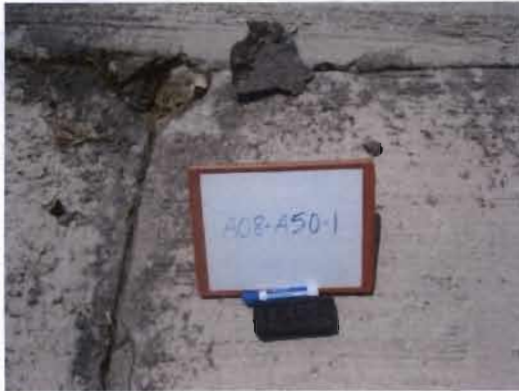
Spalling was very prevalent across the entire dome. Although spalling was found more at the panel corners, there was significant spalling along the joint edges, and sometimes along cracks on the interior of the panel.

Spalling at panel corner

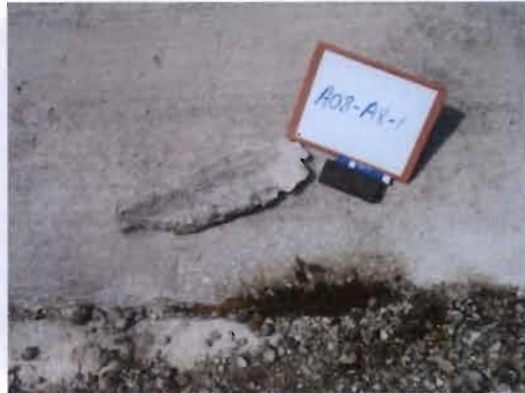
Spalling at panel edge.

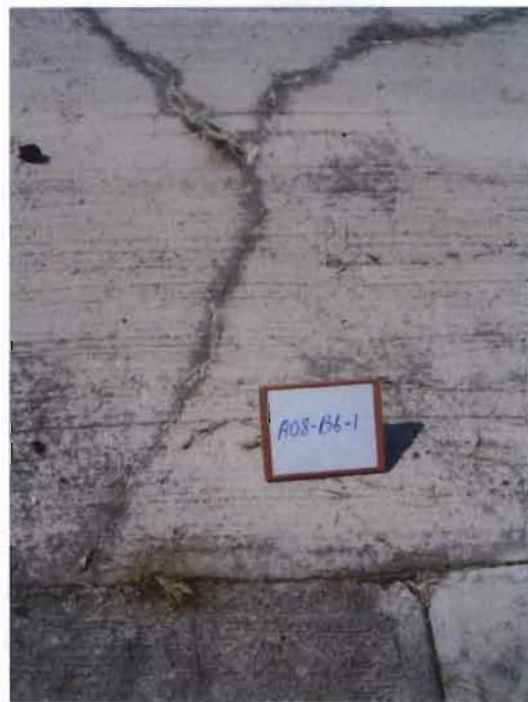
Spalling along interior crack.

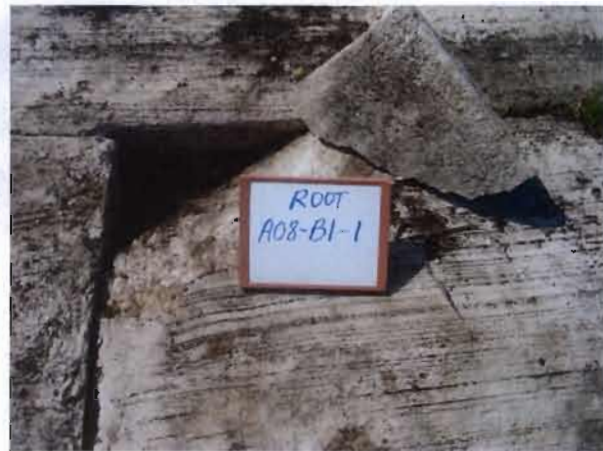
Breaking/chipping occurred in two locations at the panel corner and were about 6" deep.

6" deep broken corner #2.

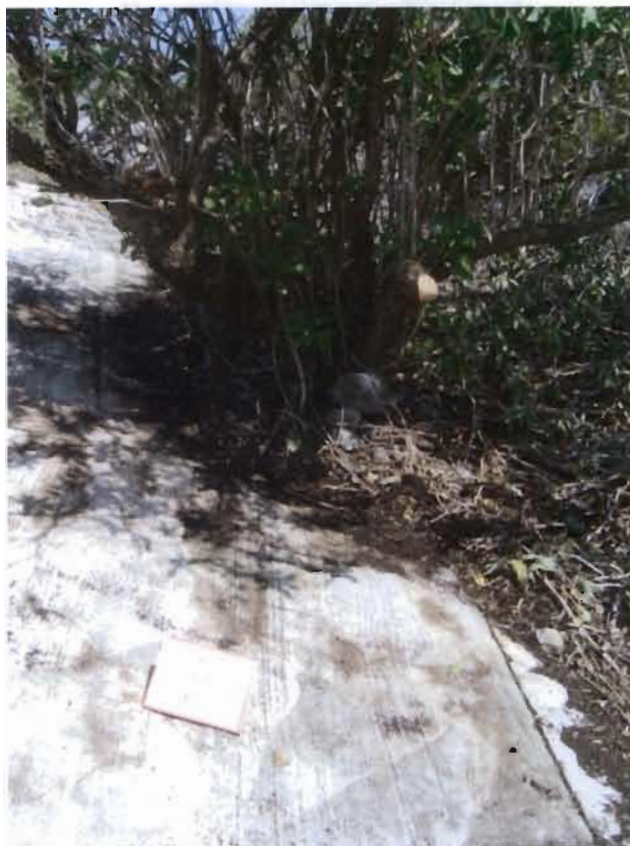
Vegetation overtaking the panels occurred in a couple places, but did not penetrate the concrete panel.

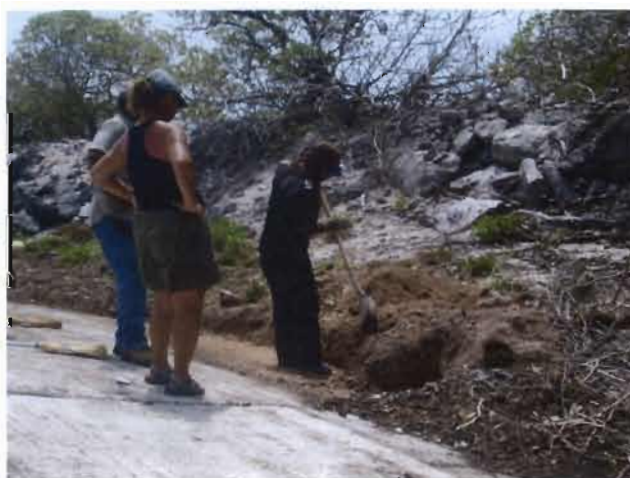
Debris covered 2' to 4' of the bottom of numerous panels. Time did not allow all this debris to be cleared for an unobstructed view of the bottom panels.
